UNDERWATER BRIDGE INSPECTION REPORT

STRUCTURE NO. 23503

ROOT RIVER

DISTRICT 6 - FILLMORE COUNTY

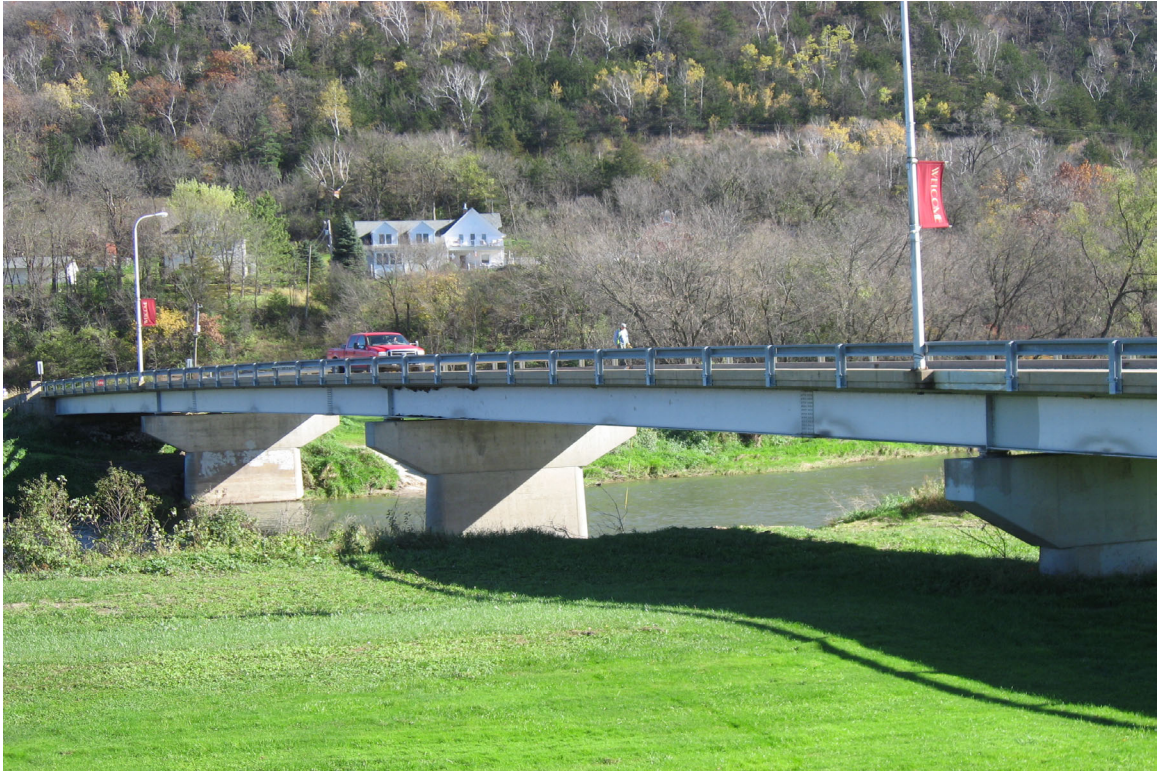
Photograph 1. Overall View of the Structure, Looking Southeast.

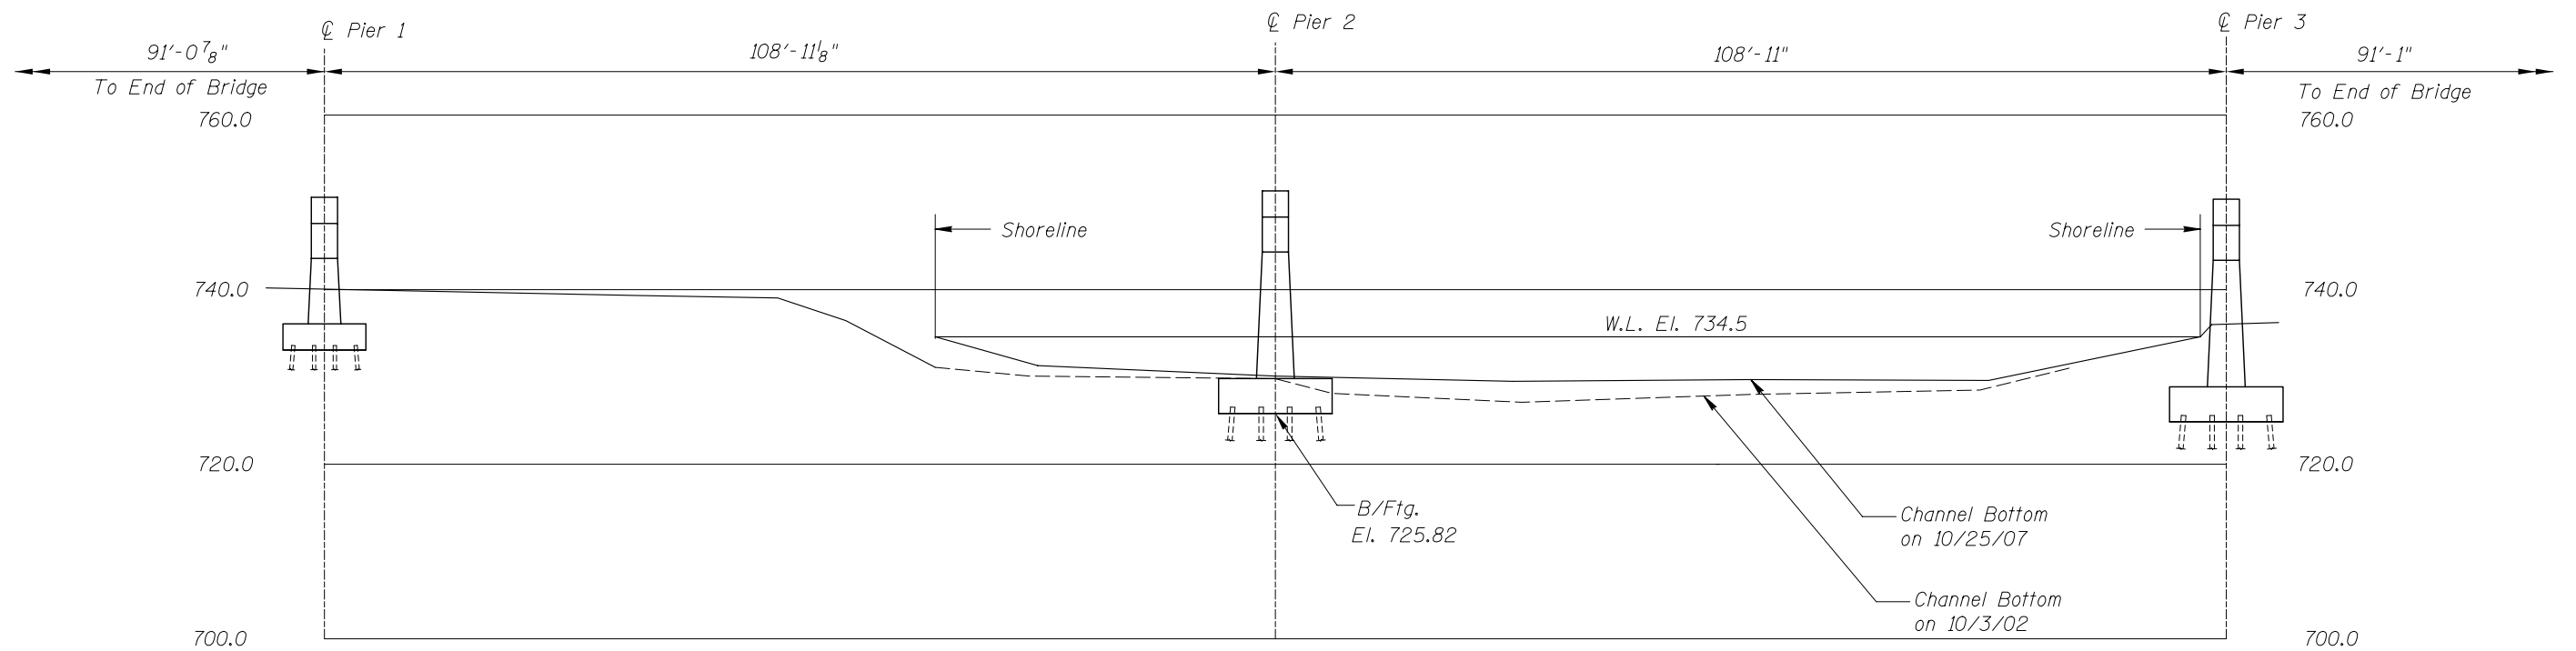
UPSTREAM FASCIA PROFILE

- 1 A light accumulation of timber debris consisting of 2 inch diameter and smaller branches was observed at the upstream nose of Pier 2 at waterline.
- 2 The channel bottom material consisted of fine sandy gravel with 2 inches of maximum probe rod penetration.

- 3 Two horizontal impact related voids were observed on the upstream nose of Pier 2 above the waterline, 2-foot-long by 1-inch-wide with 1/2 inch of penetration and exposed aggregate.

- 4 Light scaling of concrete was observed from the top of the footing (or from channel bottom at Pier 3) to 1 foot above the waterline, 1/4 inch maximum penetration.

- 5 The concrete of both piers was smooth and in good condition.
- 6 A 3-foot-radius, 3-foot-deep scour depression was observed at the upstream end of Pier 2.

- 7 The channel bottom at the downstream end of Pier 2 consisted of sandy infilling with 3 inch probe rod penetration.
- 8 A moderate accumulation of timber debris, up to 1.5 feet diameter, was observed within the scour depression at the upstream end and along the east face of the pier, extending from channel bottom up 3 feet.

Monitor the scour depression and footing exposure at Pier 2 during future inspections. If these conditions progress, repairs can be considered including filling the scour hole at the upstream end of Pier 2 by designing and placing properly sized riprap.
